FIVE-YEAR REVIEW

DAVIE LANDFILL SITE

BROWARD COUNTY, FLORIDA

PREPARED BY U.S. ENVIRONMENTAL PROTECTION AGENCY

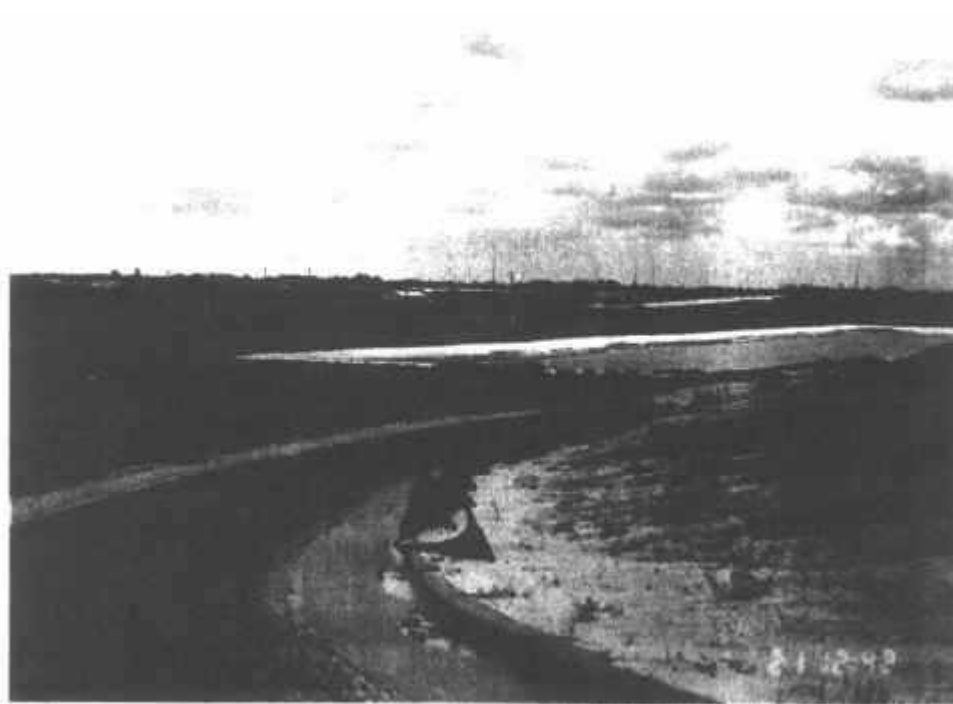
The following is a summary of EPA's observations made during the site tour with references to photographs which are included as Appendix A of this report. The tour by driving to the top of the trash landfill. The limerock cover was in place on the landfill. Asphalt paving and concrete curbing were complete (Photograph A- 1). Parking areas and trails were tack- coated. Topsoil was placed in some areas and landscaping of the 68 acre landfill was underway (Photograph A-2). From the top of the trash landfill, the sludge lagoon and lakes 1, 2, and 3 (Photograph A-3, A-4, and

Photograph A-1: Asphalt paving and concrete curbs were in place on the trash landfill during EPA's September 1993 site visit.

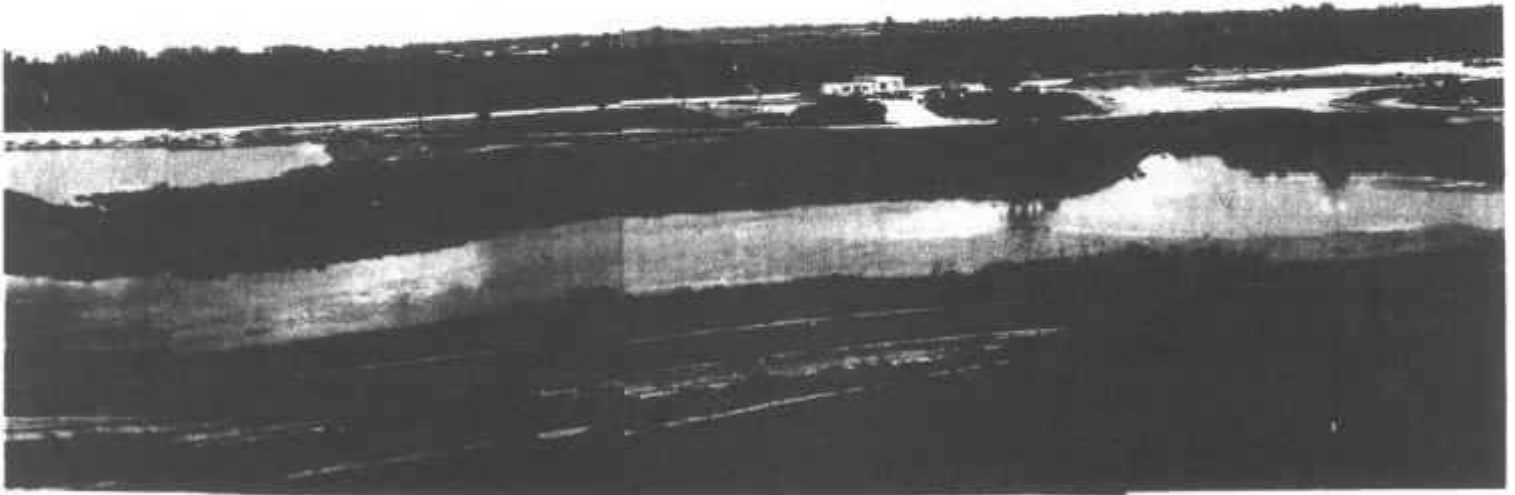
A-5) were observed. Several species of water fowl were observed in the sludge lagoon. There was algae on the surface in some areas of the lagoon. Vegetation surrounding the lagoon appeared to be thriving.

The landfill closure was not complete by the time this five- year review was conducted. The sludge lagoon appears to have been restored to a thriving wetland area. The stabilized contents of the sludge lagoon appear to be structurally sound.

Photograph A-3: Sludge lagoon appeared to be a thriving wetland (September 1993).

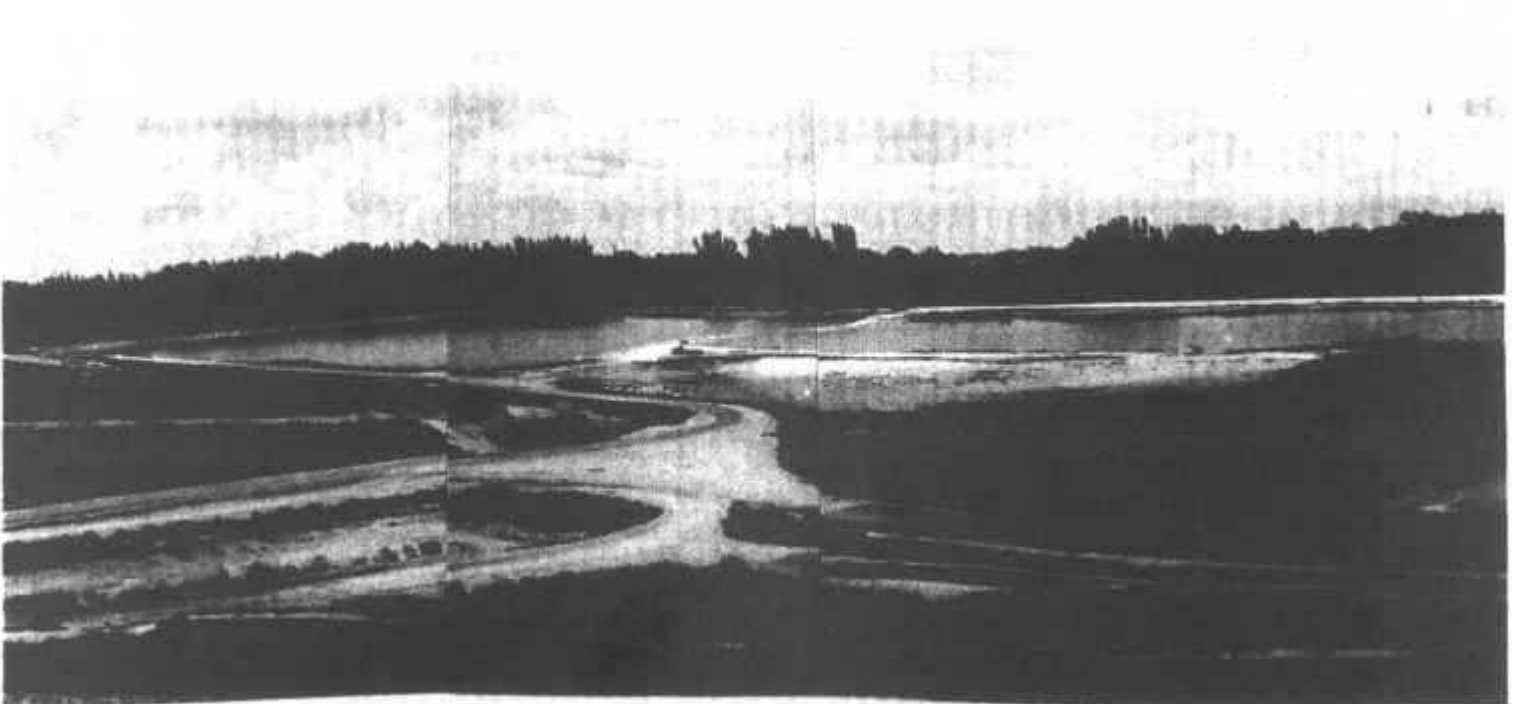
Photograph A-4: Lakes 1 and 2 were connected as part of the landfill closure (September 1993).

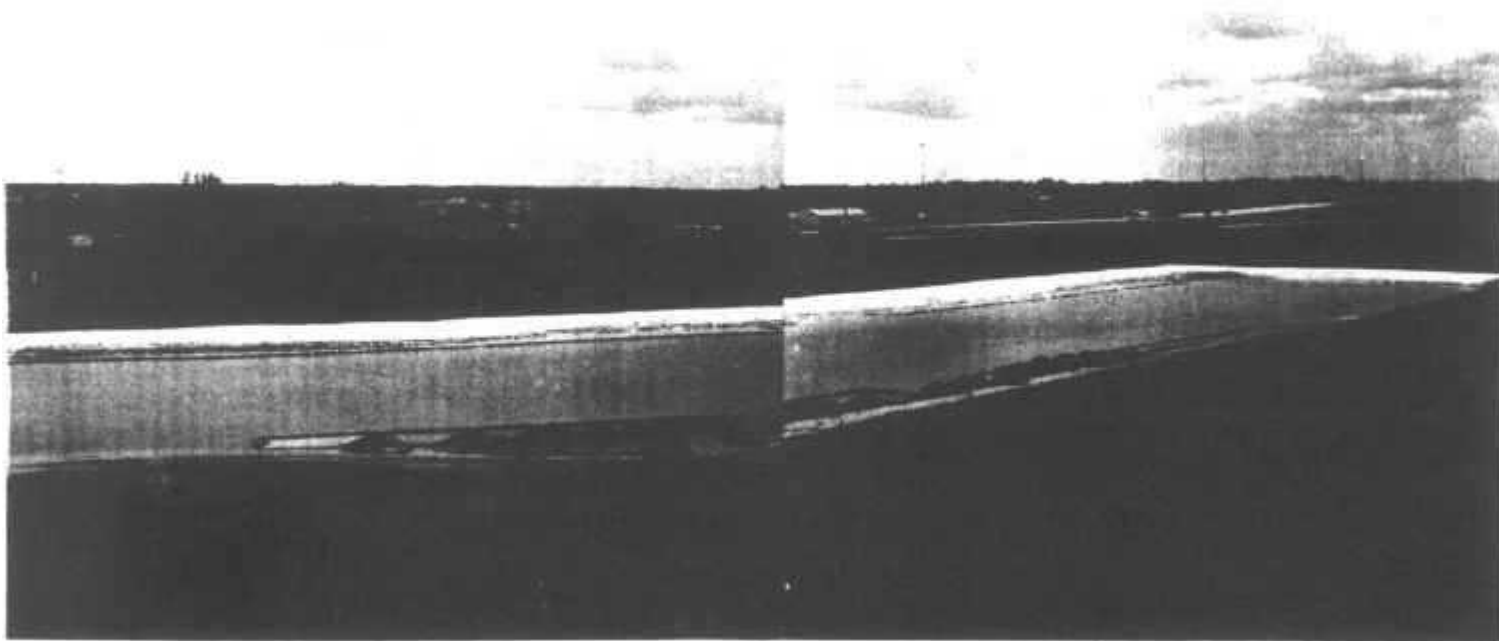
Photograph A-5: Lake 3 bounds the south west portion of the site (September 1993).

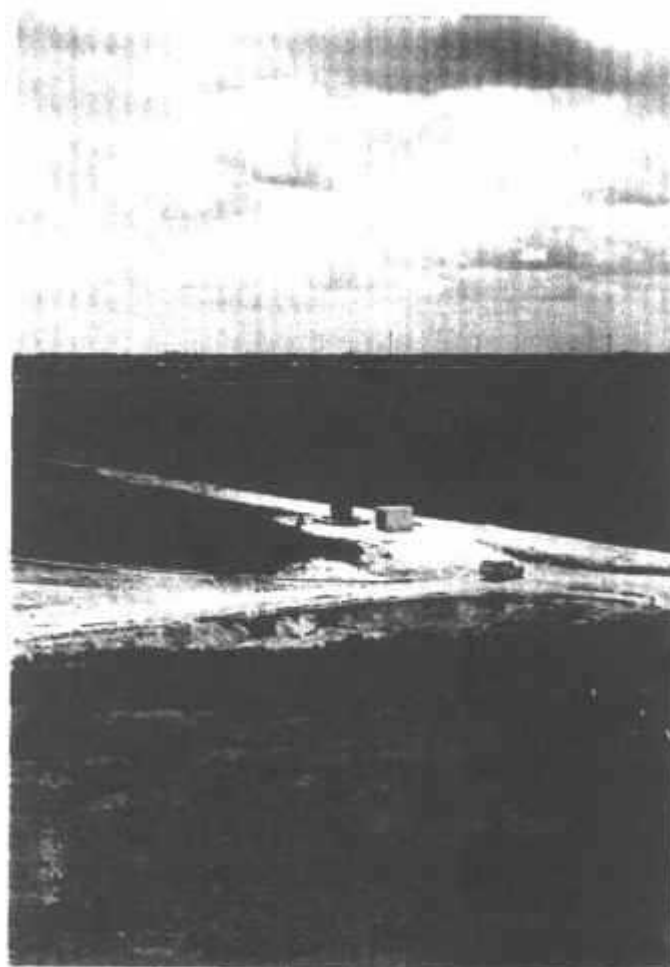
Next, the tour proceeded down the access road at the north end of the trash landfill and inspected the enclosed flare system designed to burn landfill gas collected in the sanitary landfill (Photograph A-6). The piping to the flare was not complete at the time of this visit.

Photograph A-6: Enclosed flare under construction (September 1993).

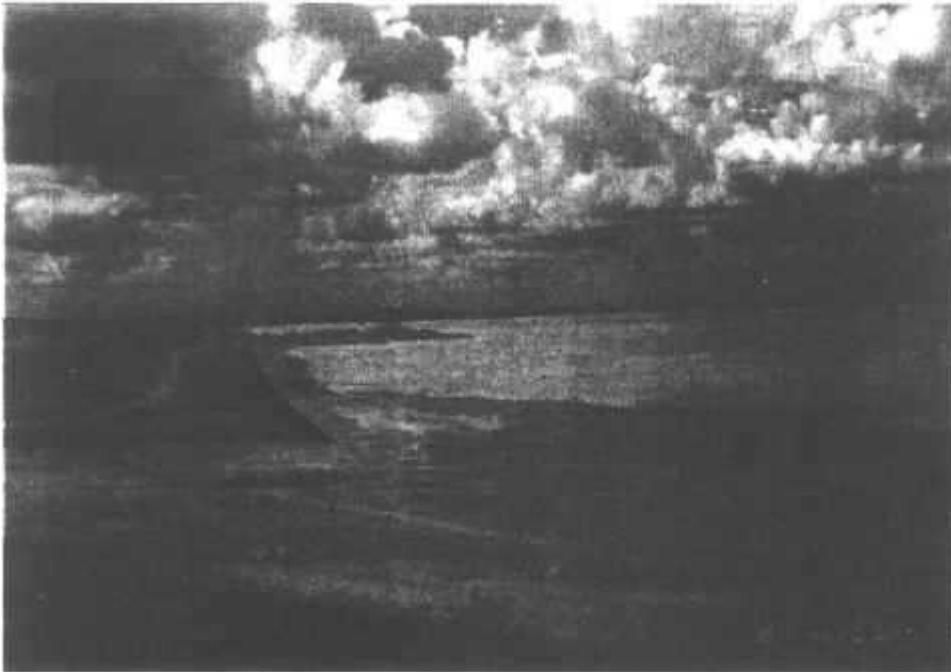
The tour proceeded to the top of the sanitary landfill. The limerock cover was in place on most of the sanitary landfill (Photograph A-7), although some areas still required fill (Photograph A-8).

Photograph A-7: Limerock cover on sanitary landfill (September 1993).

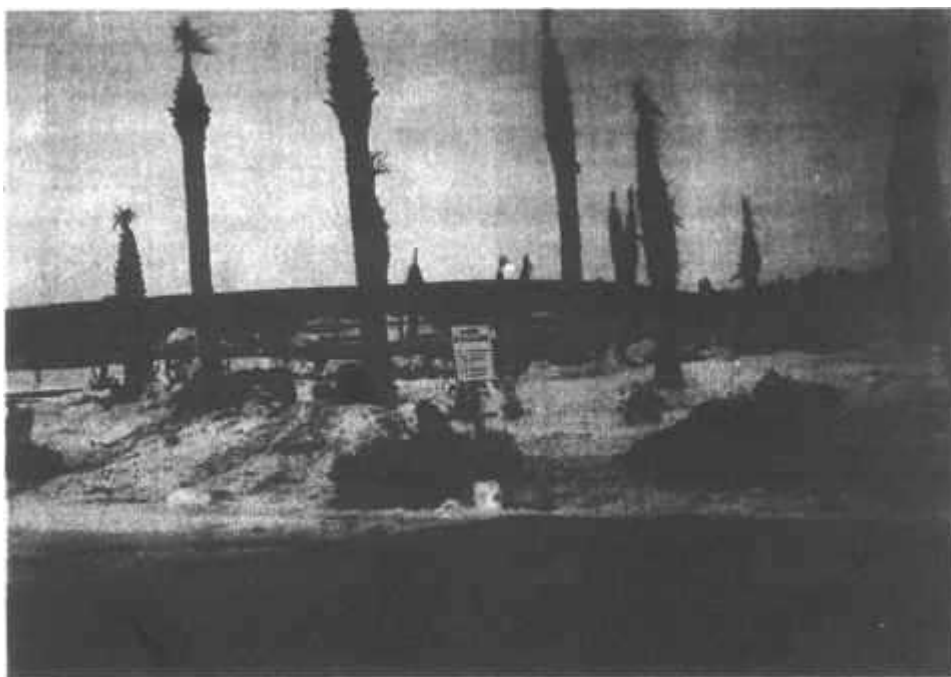
Ms. Scully visited the site again on December 15, 1993. The landscaping at the site entrance and trash landfill were well underway (Photographs A-10). Most of the grading was complete (Photograph A-11), and the enclosed flare was complete but not yet operating (Photograph A-12)

Photograph A-10 : By December 1993, landscaping at the landfill entrance was underway.

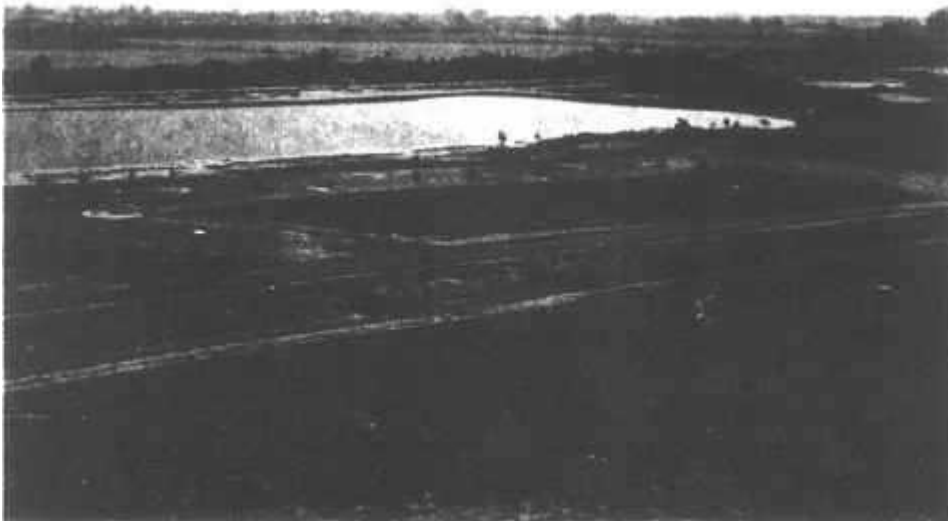
Photograph A-11 : Grading was essentially complete in December 1993.

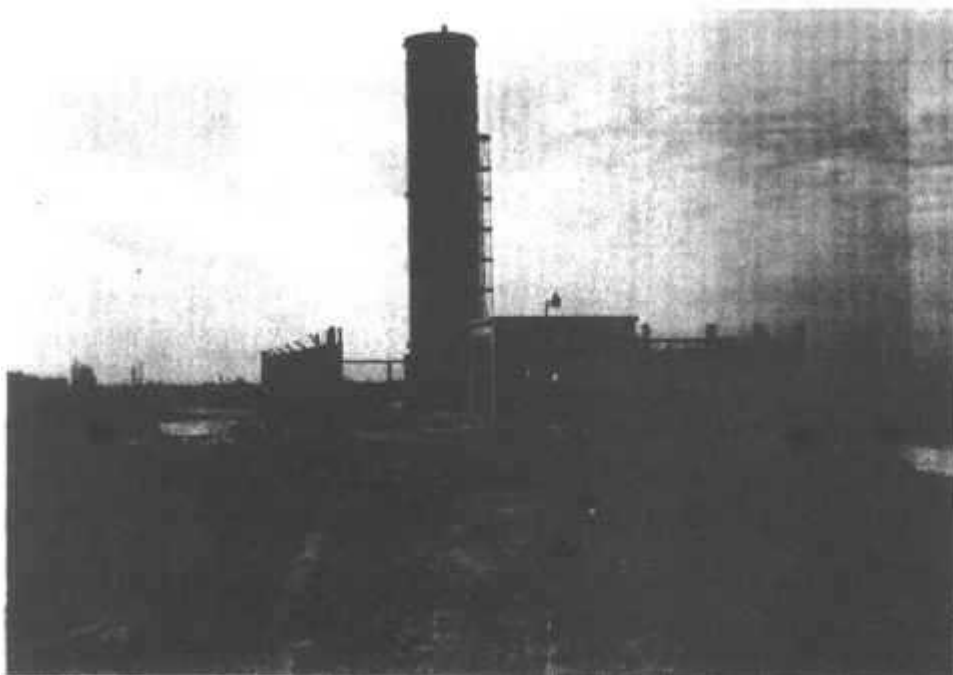
Photograph A-12 : Enclosed flare construction appeared to be physically complete in December 1993.
